## ST DAVID'S HALL - RAAC ROOF PLANK SURVEY

TYPE OF DOCUMENT (VERSION) PUBLIC

PROJECT NO. 70086249

OUR REF. NO. WSP-XX-XX-RP-S-000001

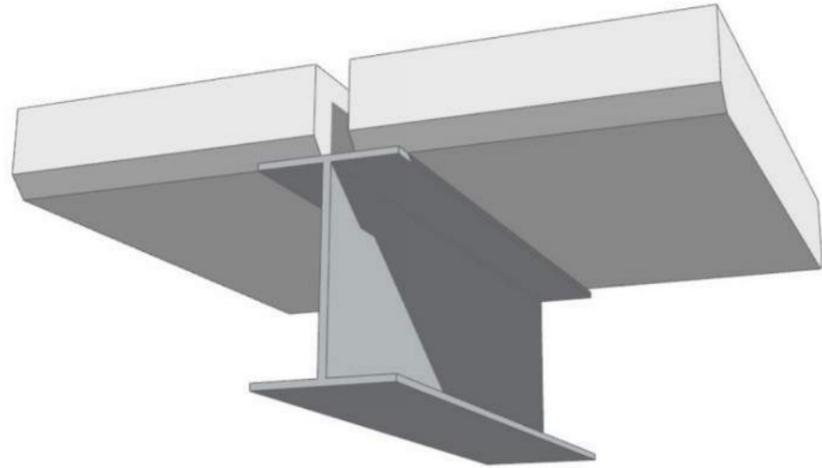
Sub-standard bearing on 100mm beam

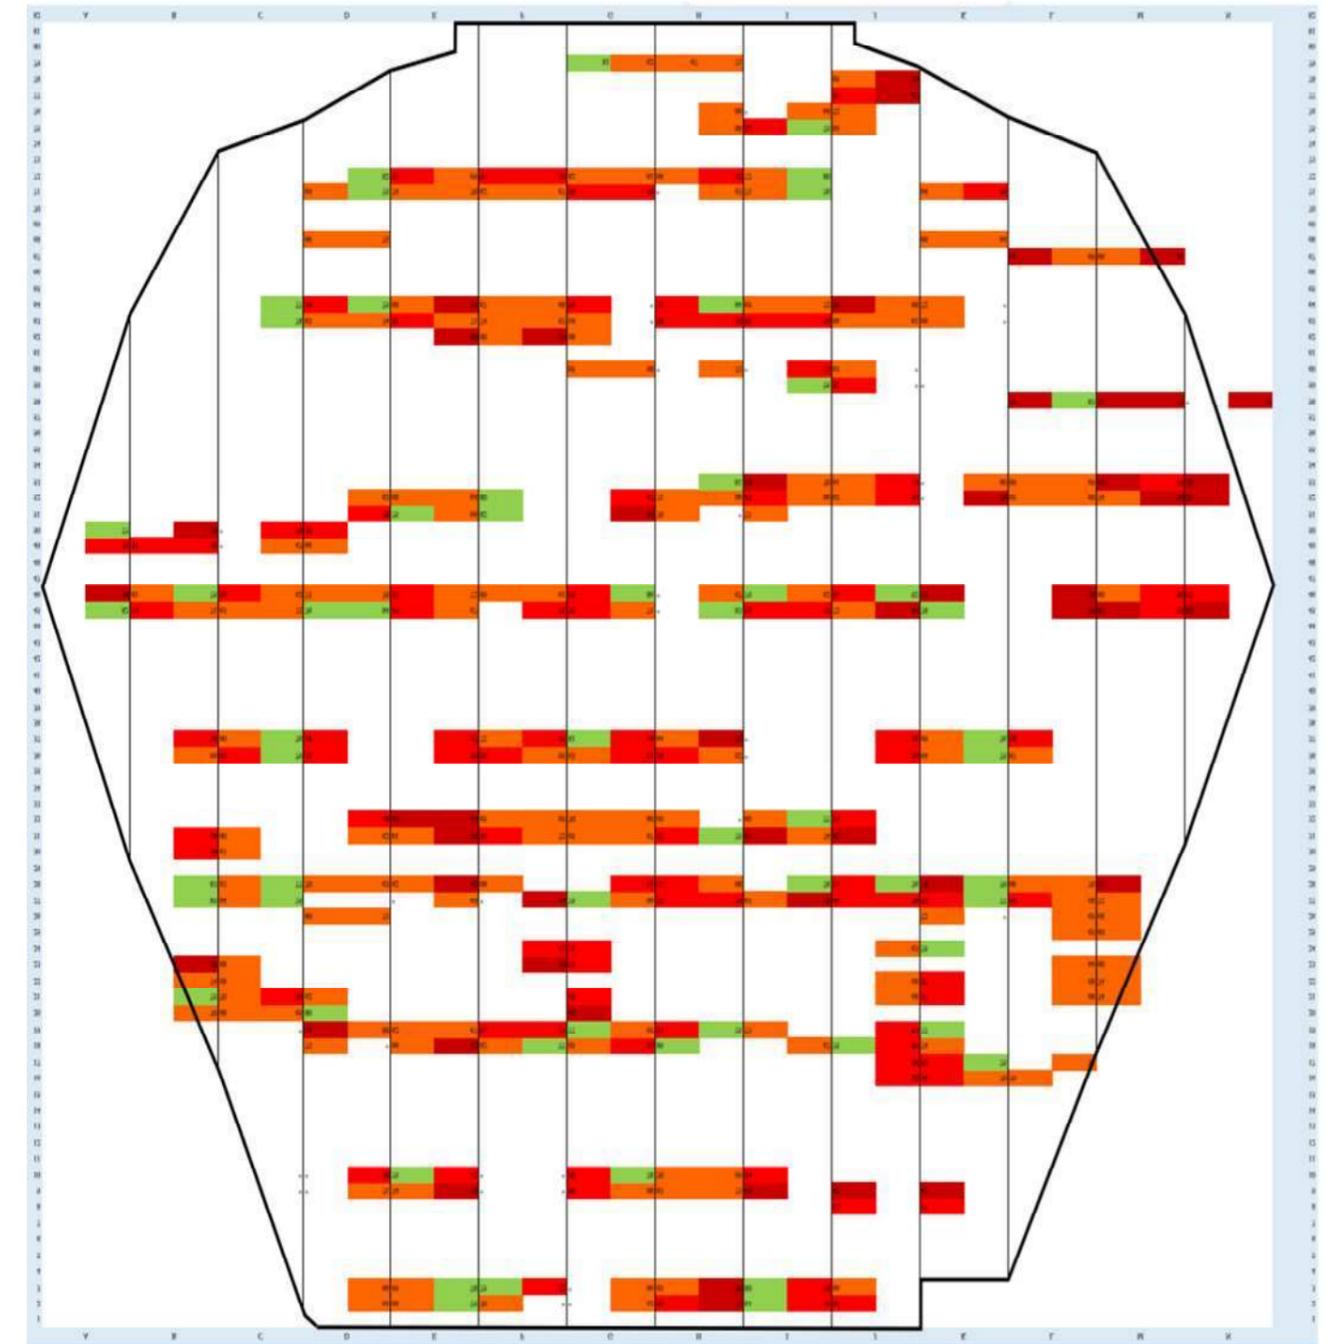
Figure 3-3 - End bearing length of RAAC roof panels

Analysis of results at St David's Hall found the minimum measured end bearing length to be CIRCA 25mm in 3no. locations.

As per guidance provided in *Reinforced Autoclaved Aerated Concrete (RAAC Investigation and Assessment – Further guidance, IStructE, April 2023)*, a minimum bearing length of 75mm is now considered to be the standard minimum. Any bearing <75mm is considered substandard and presents an unacceptable risk for which remedial actions are recommended.

Analysis of results found the maximum measured end bearing length to be 92mm.

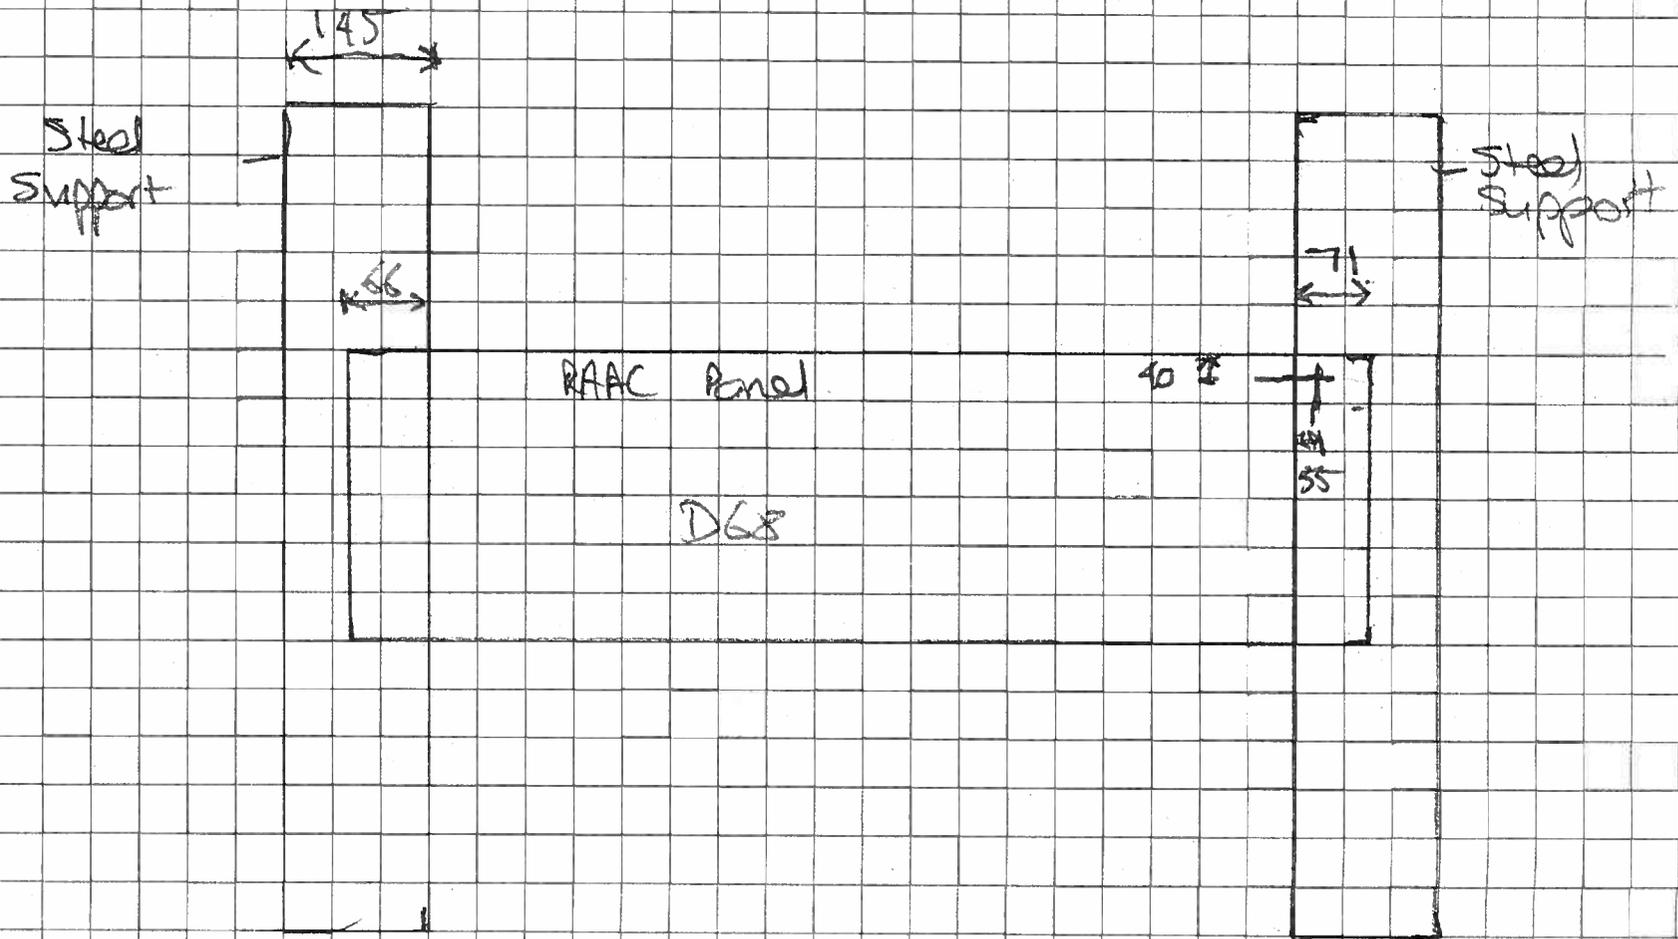
**Intrusive investigation - D68**

5-6 mm rebar

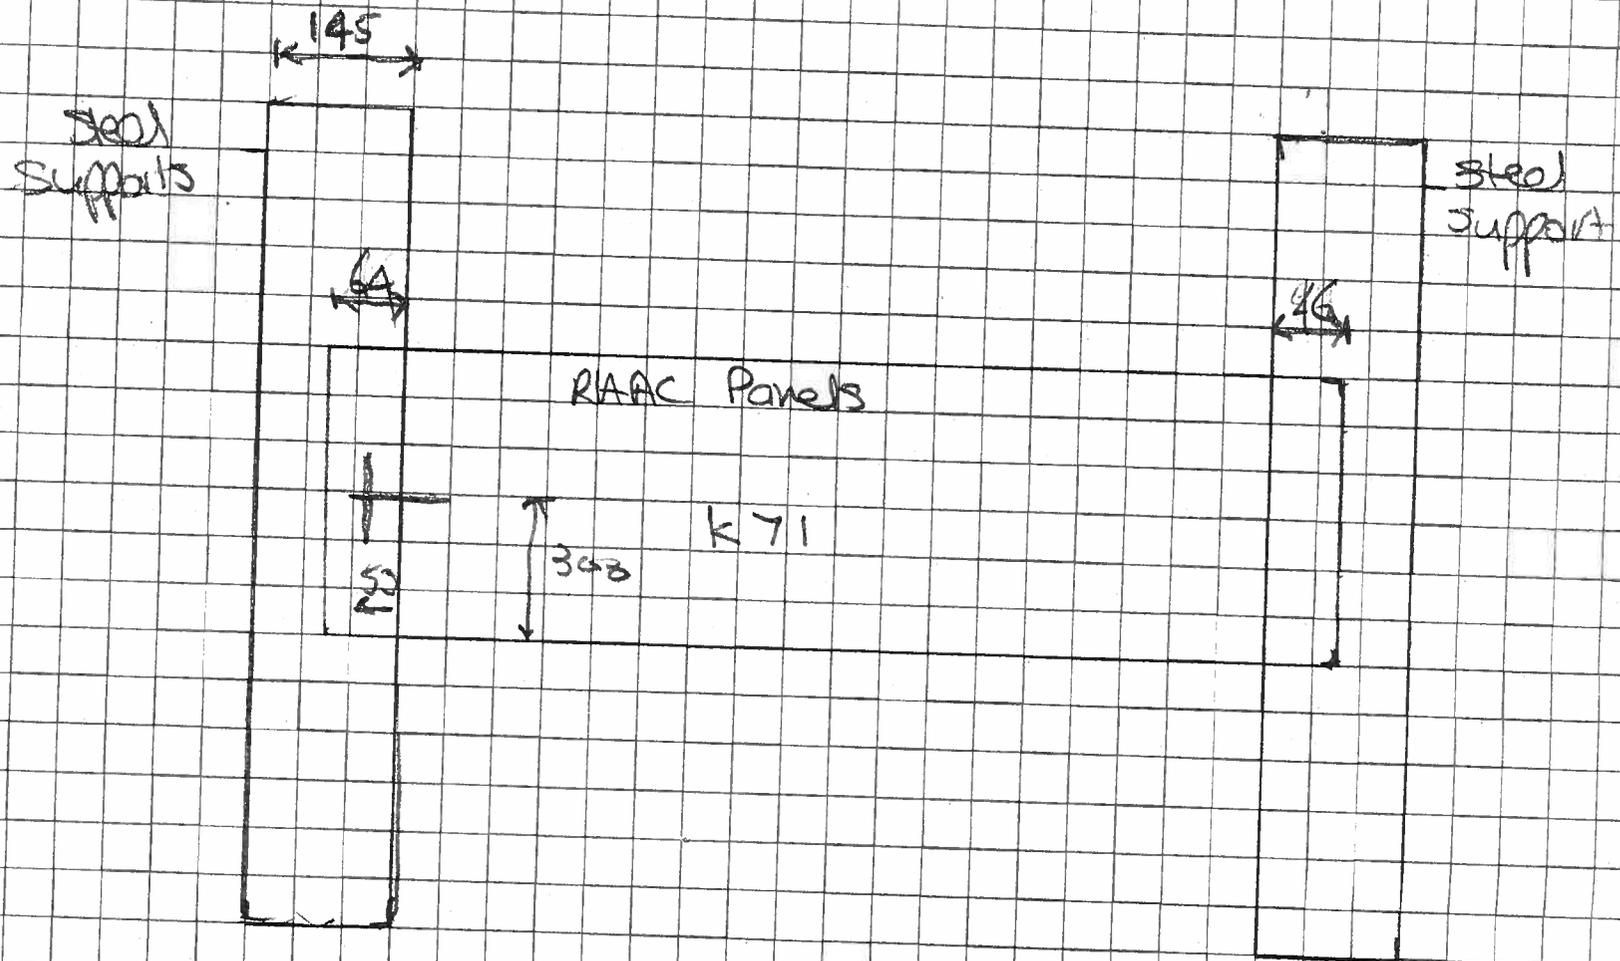
**Intrusive investigation - K71**

6 mm rebar?

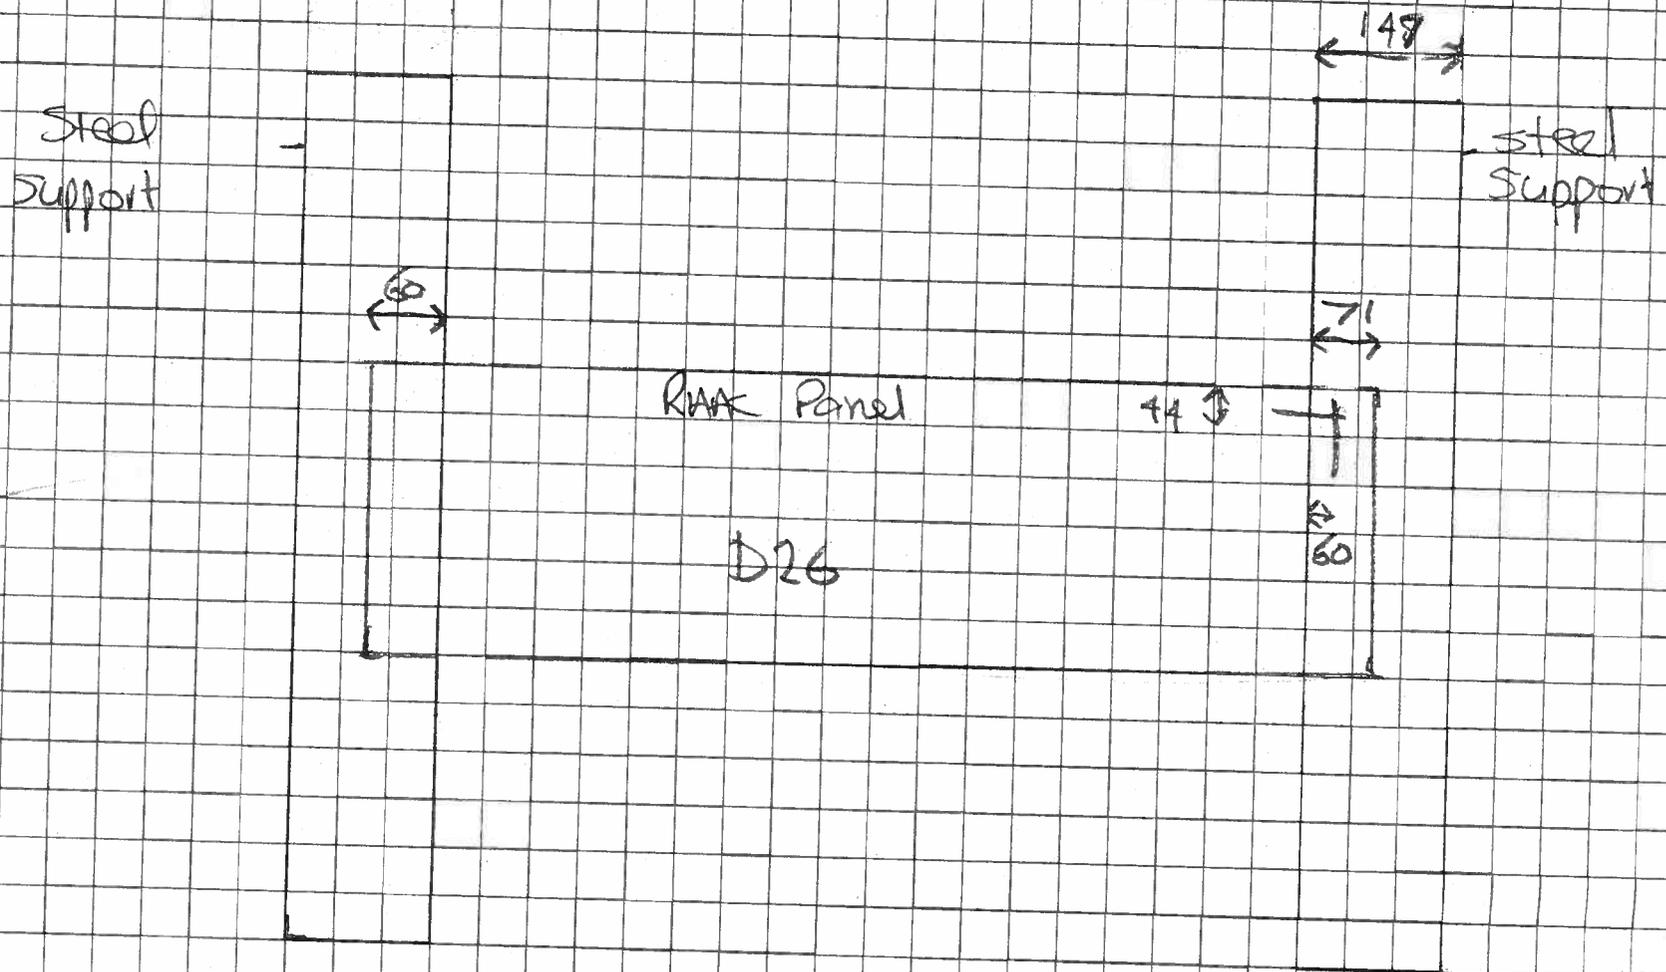
**Intrusive investigation - D26**

6 mm rebar

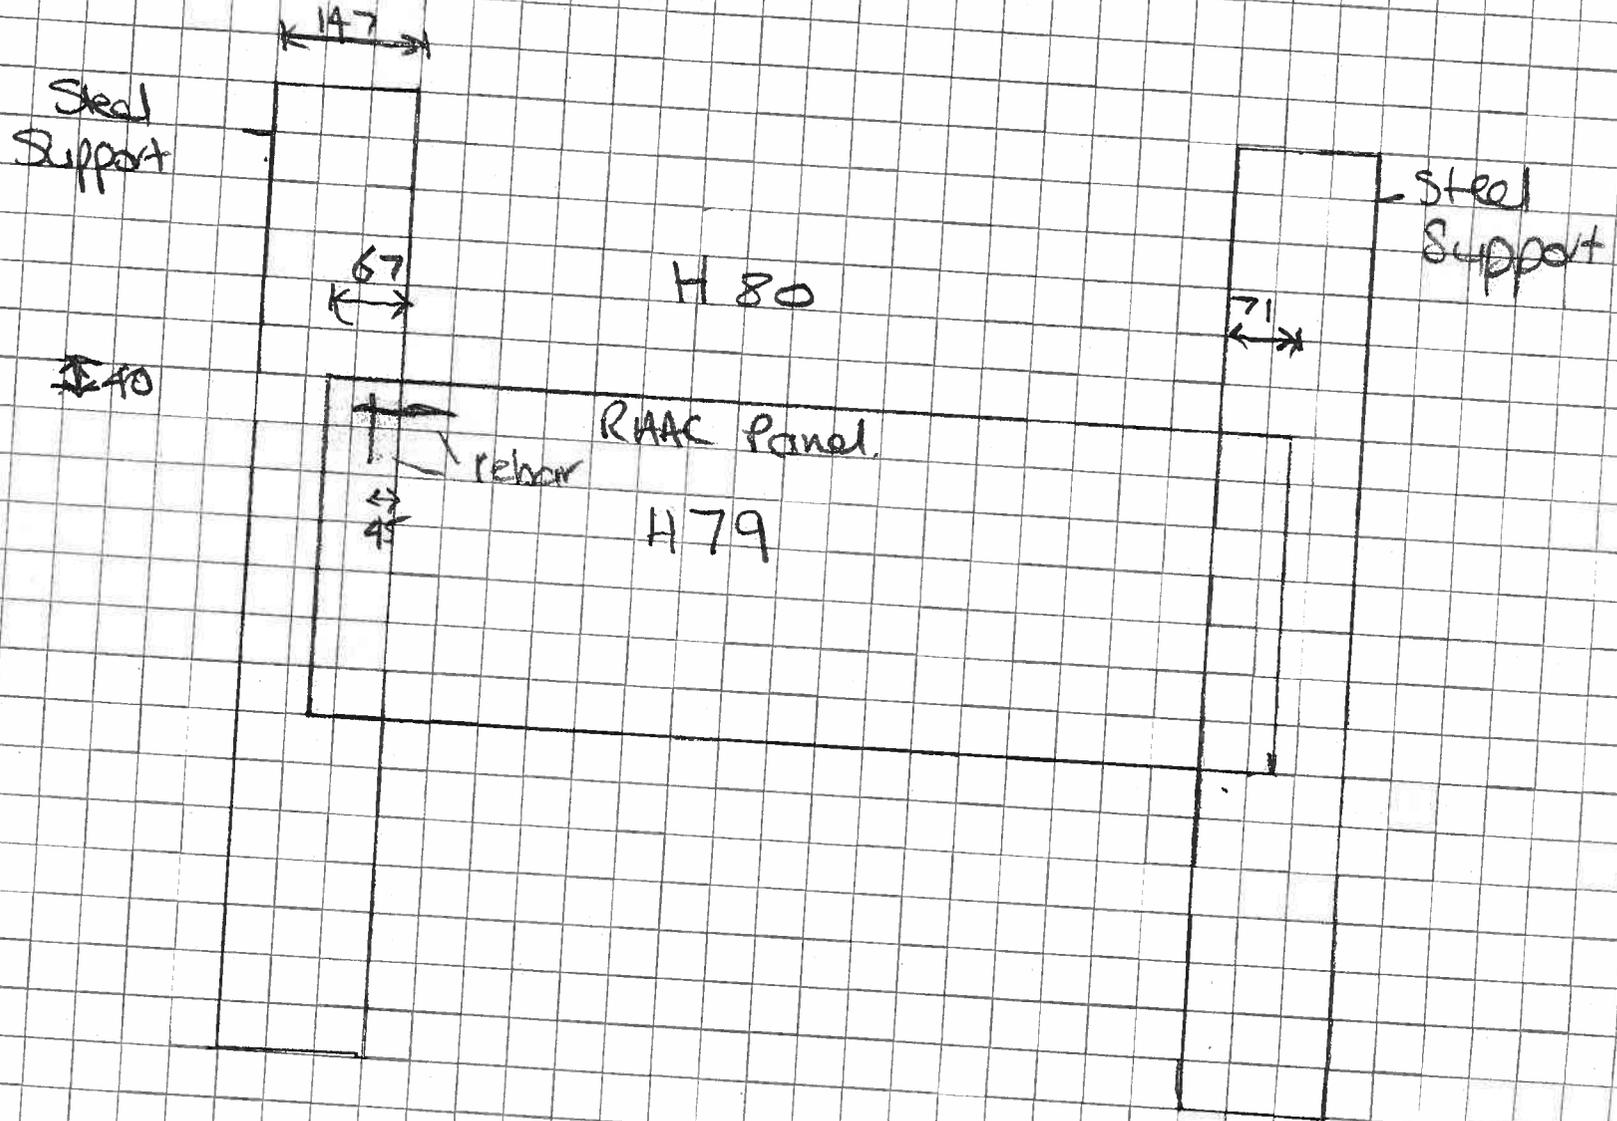
**Intrusive investigation - H79**

6mm rebar

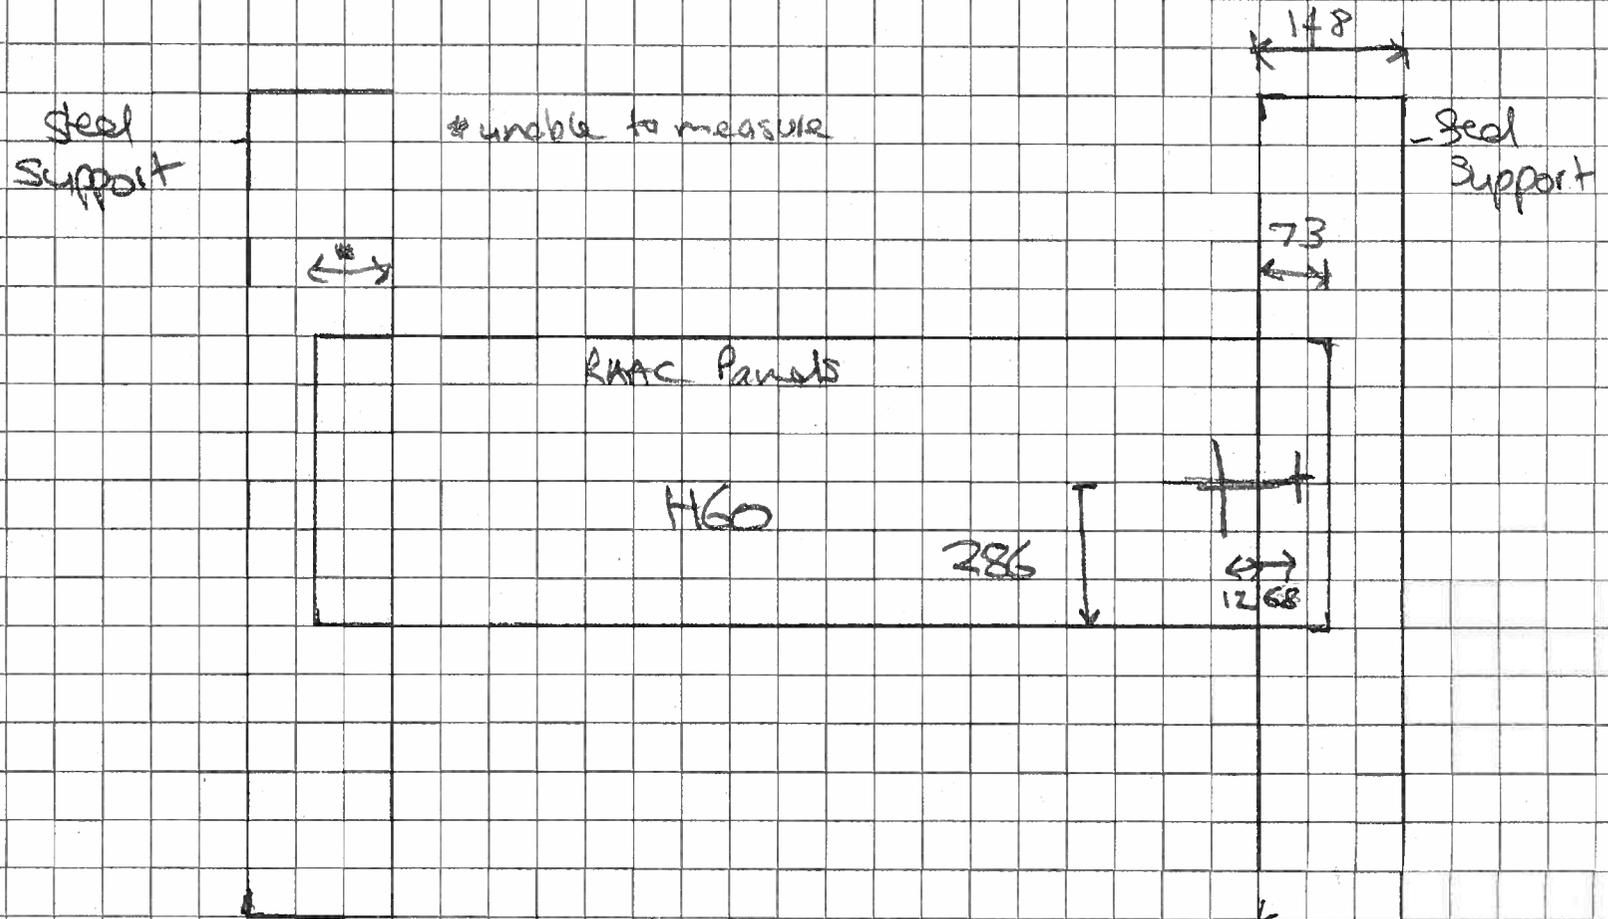
# Intrusive investigation - H60

6mm repair
