Issues so far this term for EY Building at Moorland Primary School (15/10/22)

Moorland Early Years Building November 8th 2022

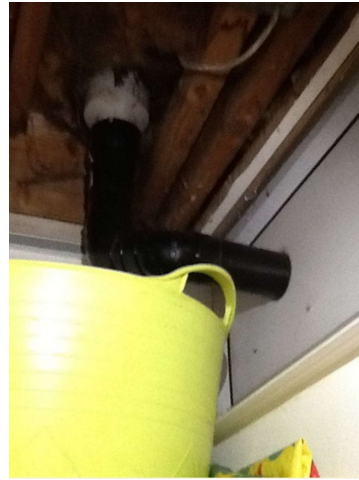
The leaking roof has supposedly been repaired and sealed but continues to leak. Picture shows area below repair. Further call logged

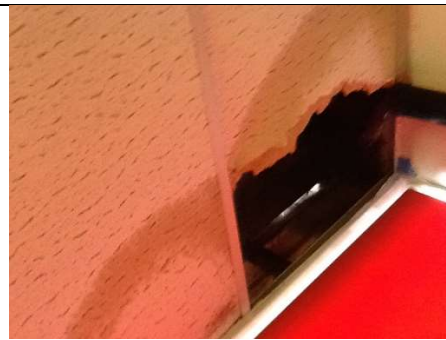
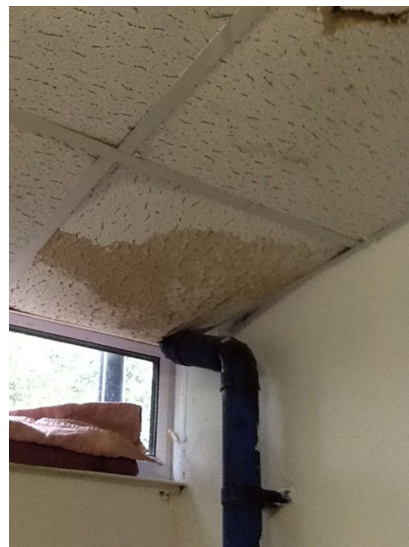
Ceiling tiles are replaced regularly but are continuing to bow as filled with water. This will eventually come down. Around the (internal) pipe water is dripping down and soaking the carpet. The whole area smells of damp

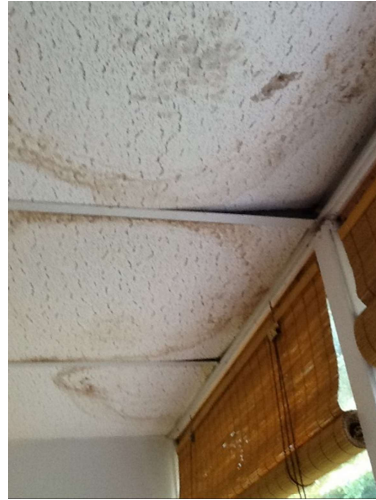
In the other end of the building the ceiling tiles have not long been replaced and are already bowing with water.

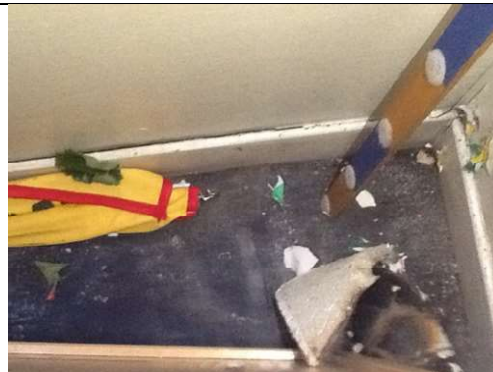
This week a bit of ceiling tile fell down on a child during a teaching session

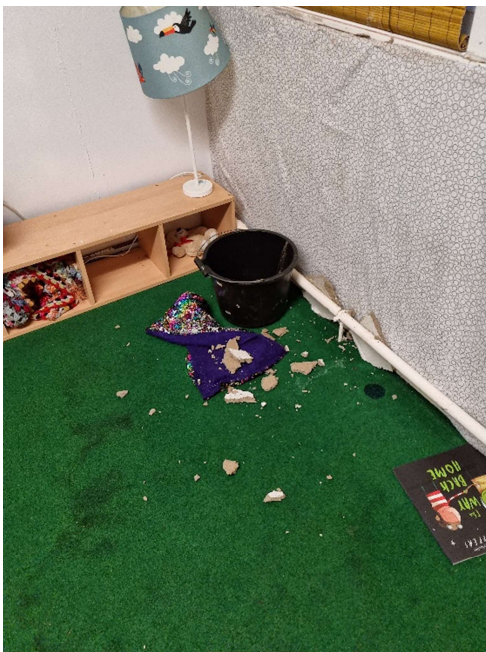
Classroom area now taken out of use. These are new ceiling tiles under the most recent roof repair. Due to significant risk of further falling of tiles restricted access for children

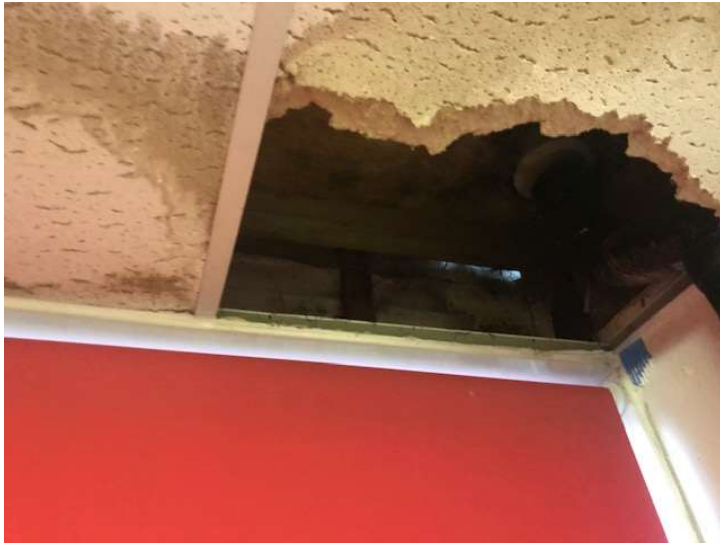
Area beneath where some ceiling tiles have already fallen in the classroom
