CARDIFF CENTRAL MARKET

Visual Aids

May 2023

ALWYN
JONES

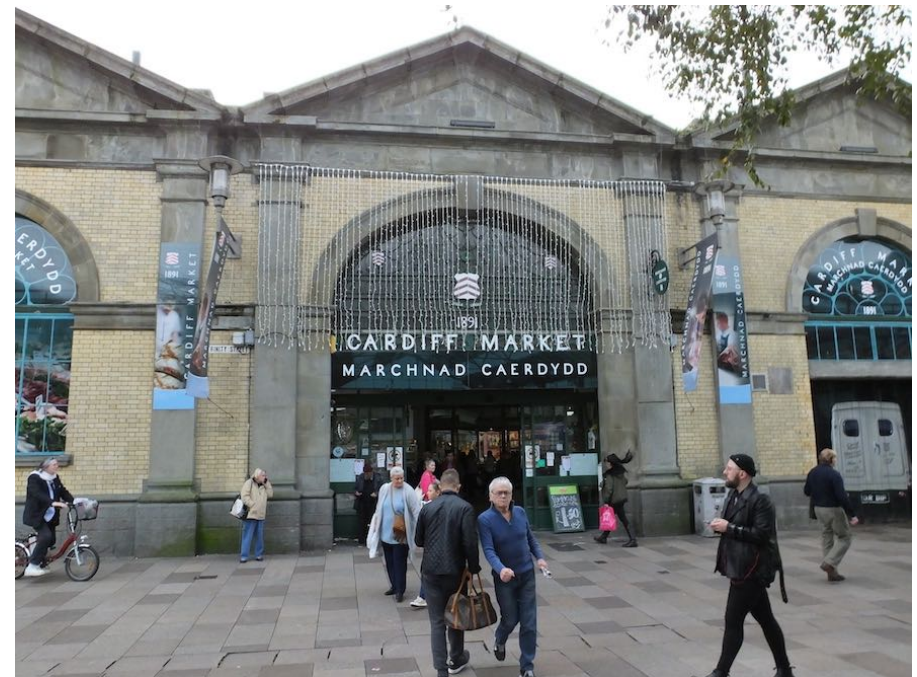
Trinity Street entrance with fine cast iron work tracery not given the prominence it deserves

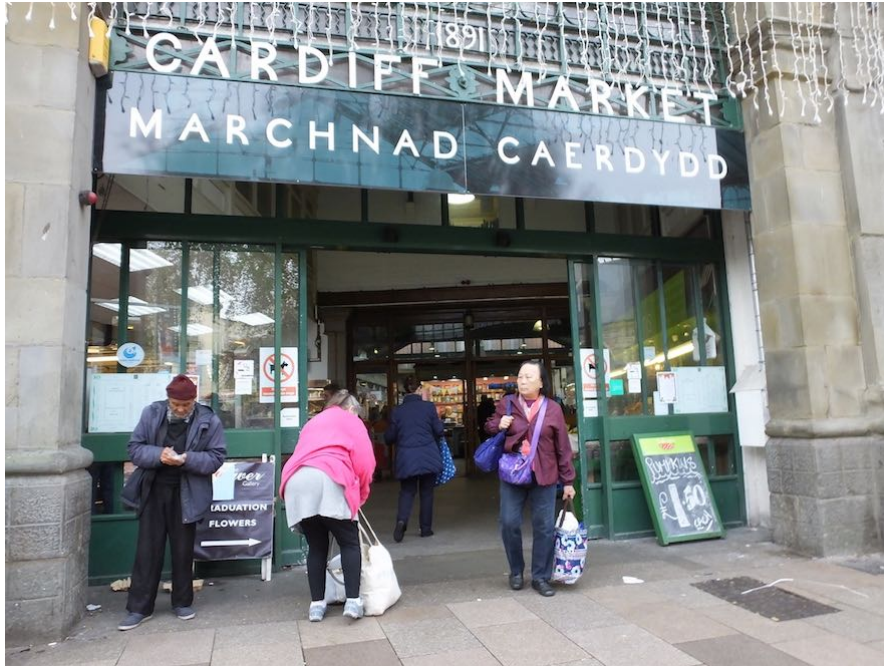
Entrance doors. Recently applied Welsh signage is a distraction from the cast iron tracery. Doors to be replaced and ironwork above refurbished.

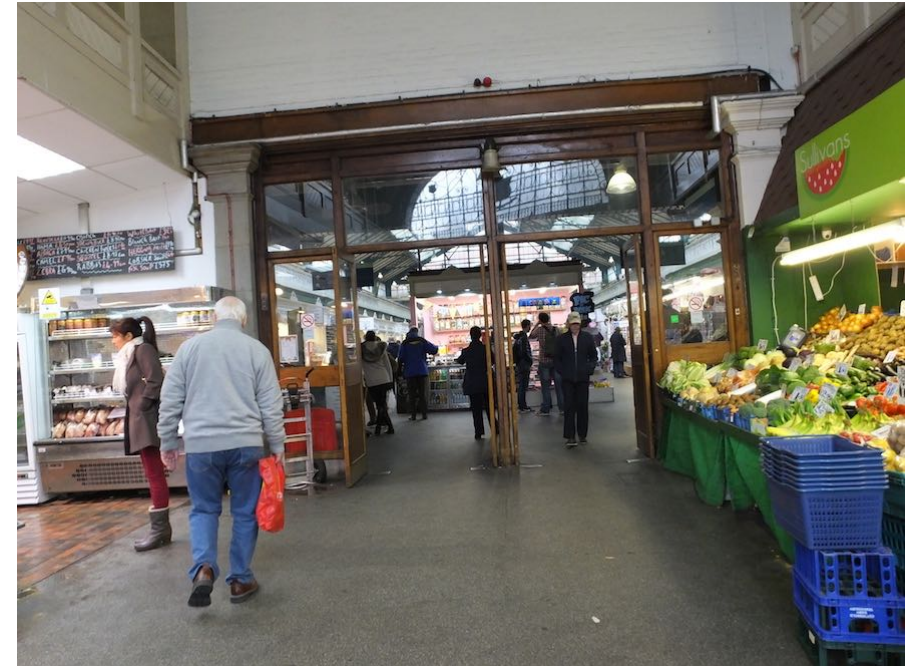
New purpose made Welsh language signage is proposed to be installed above the inner door. Inner doors to be replaced. Current stall installations conceal many of the buildings fine features eg pilasters

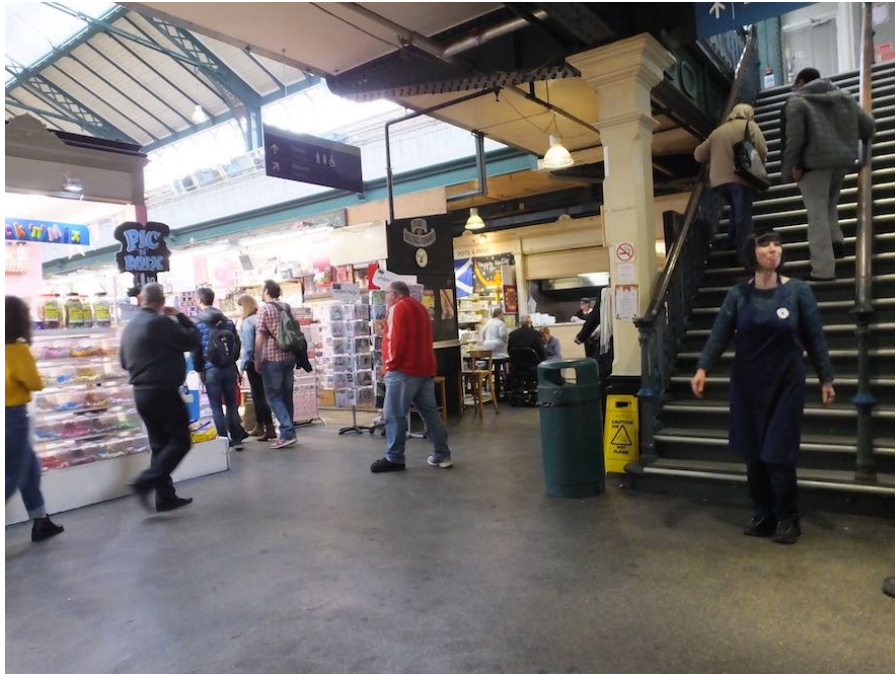
Market hall interior with fine ironwork columns and gallery structure but not shown to its full potential.

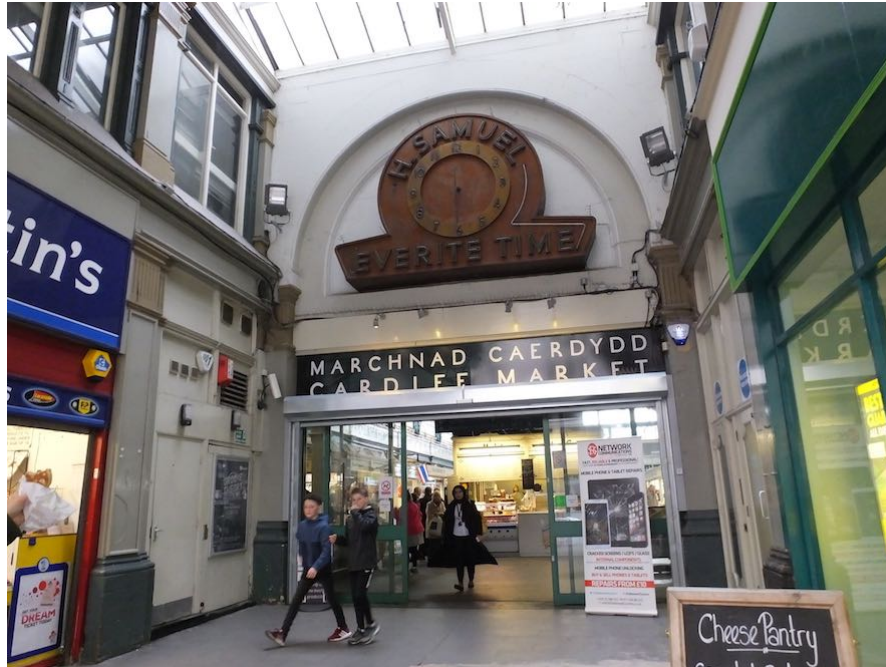
St Mary Street entrance with H Samuel neon clock – to be refurbished.
New signage to be provided to entrance and passage to be refurbished generally.

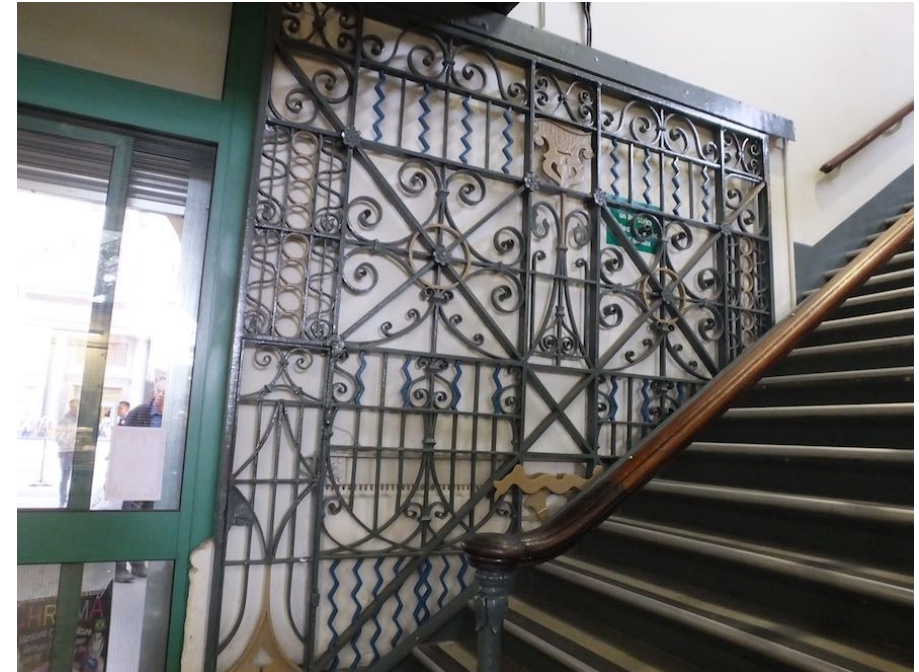
The fine sliding steel gates to the St Mary Street entrance.

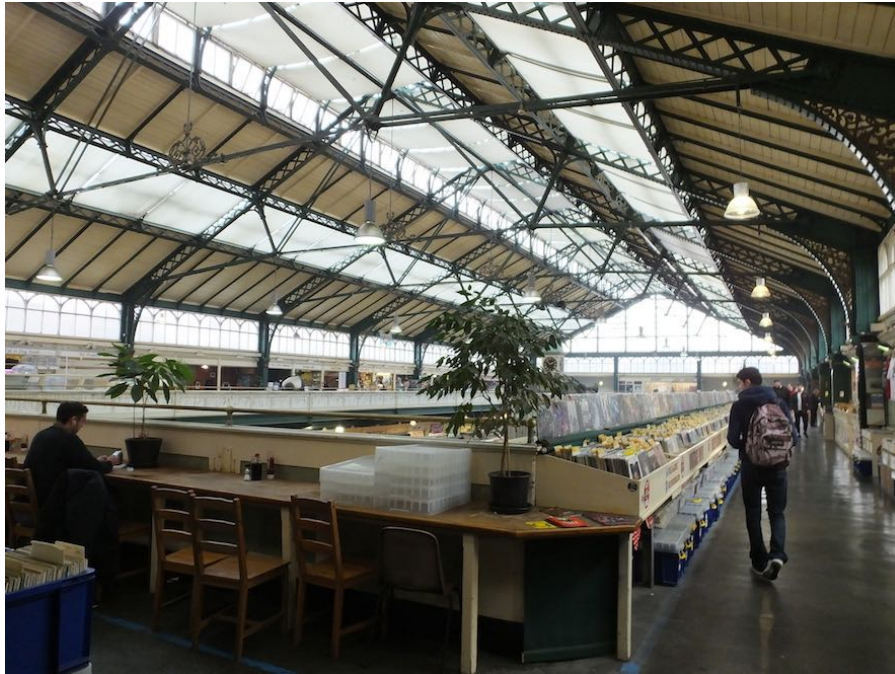
Fine Victorian engineering to the Market roof with lattice trusses.

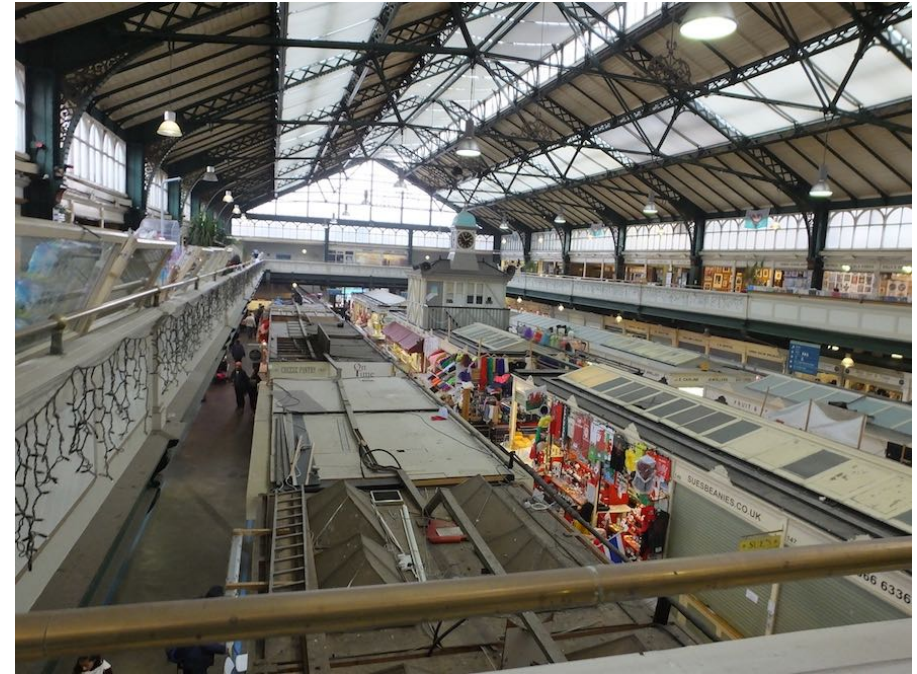
The Market viewed from the gallery. The closest row of stalls have been constructed ad-hoc in place of an original table-top stall arrangement and are of poor quality. These stalls are to be replaced with new enclosures based on the design of the original centre aisle stalls.

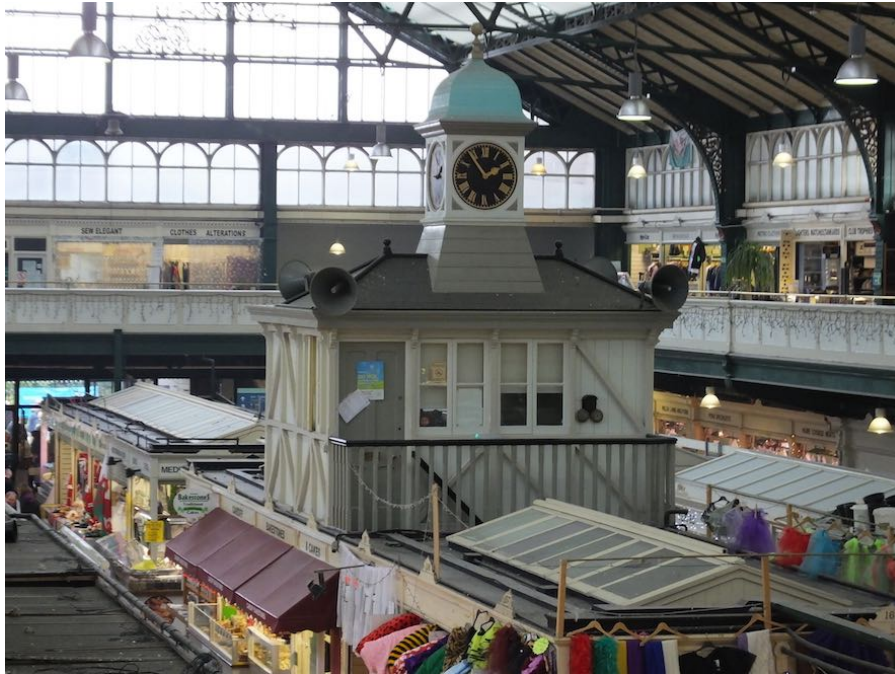
The market manager's office, still in use today.
Note also the goods and various accretions hung in front of the stalls in the foreground that detracts from the designed uniformity of the stalls.

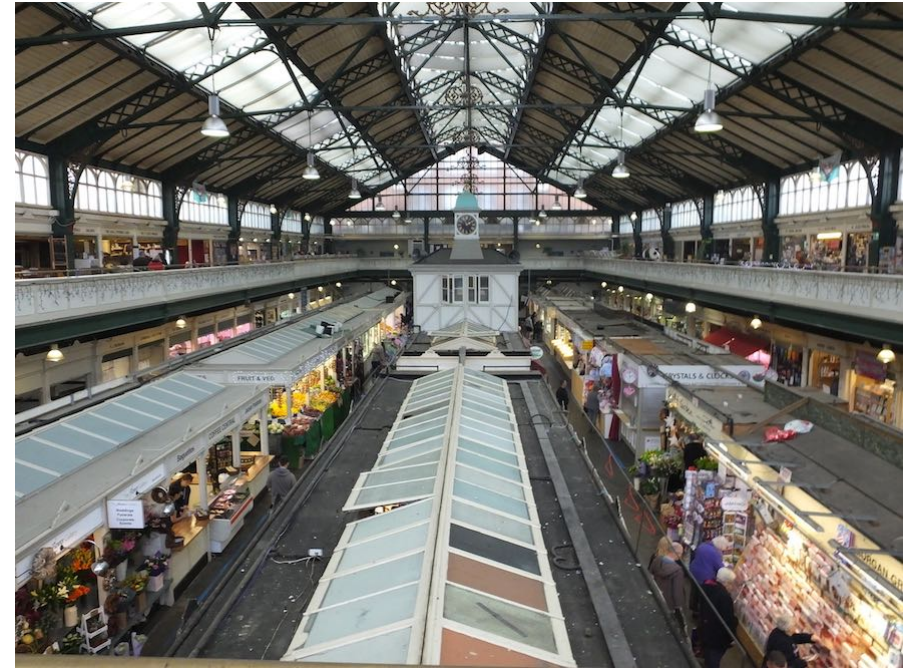
View from gallery. Note that the stalls to the left and centre aisles have been refurbished (2010) with improved roof arrangements, although numerous buckets have been placed on the roof of the left aisle to catch drips from the roof above.

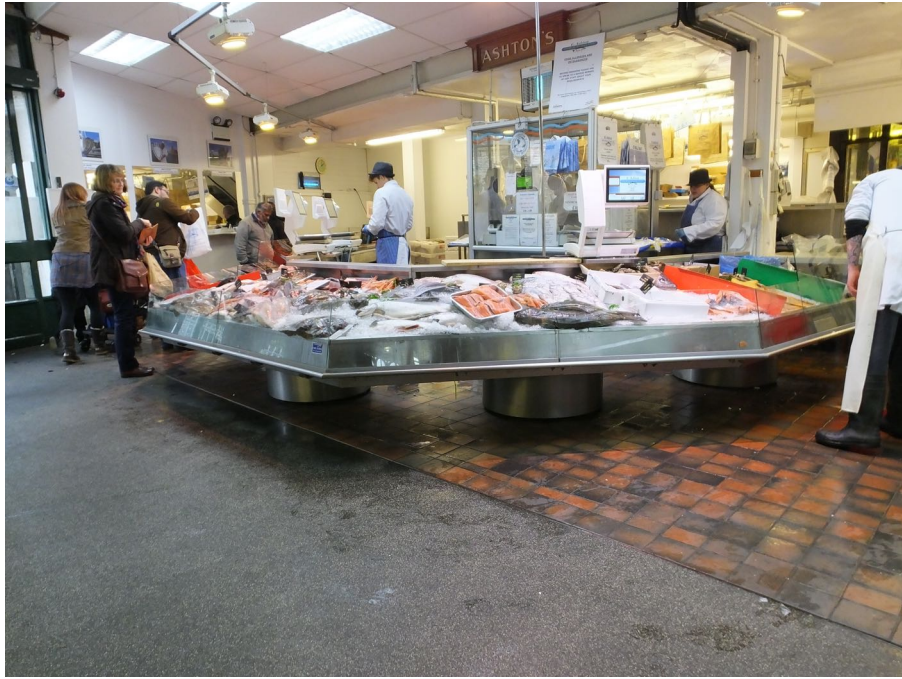
The fish market stall has been much adapted with a new mezzanine floor added (believed to be during 1960's) which conceals much of its original fine character. It is proposed to remove this intervention and refurbish the area.

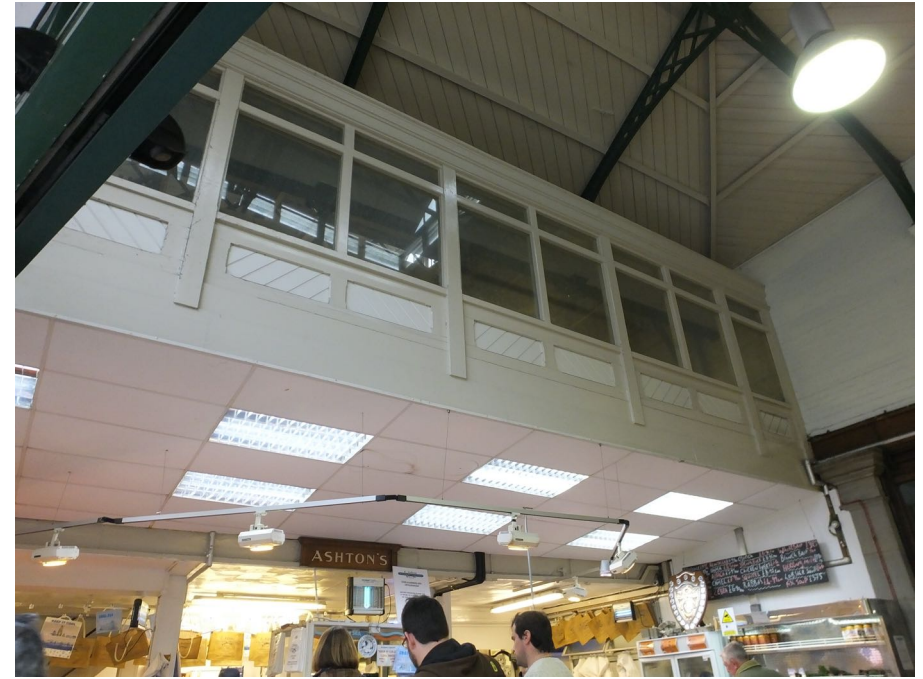
View of the added mezzanine first floor structure and screen which is to be removed. Note the visible elements of the finely detailed roof structure of the original fish market above.

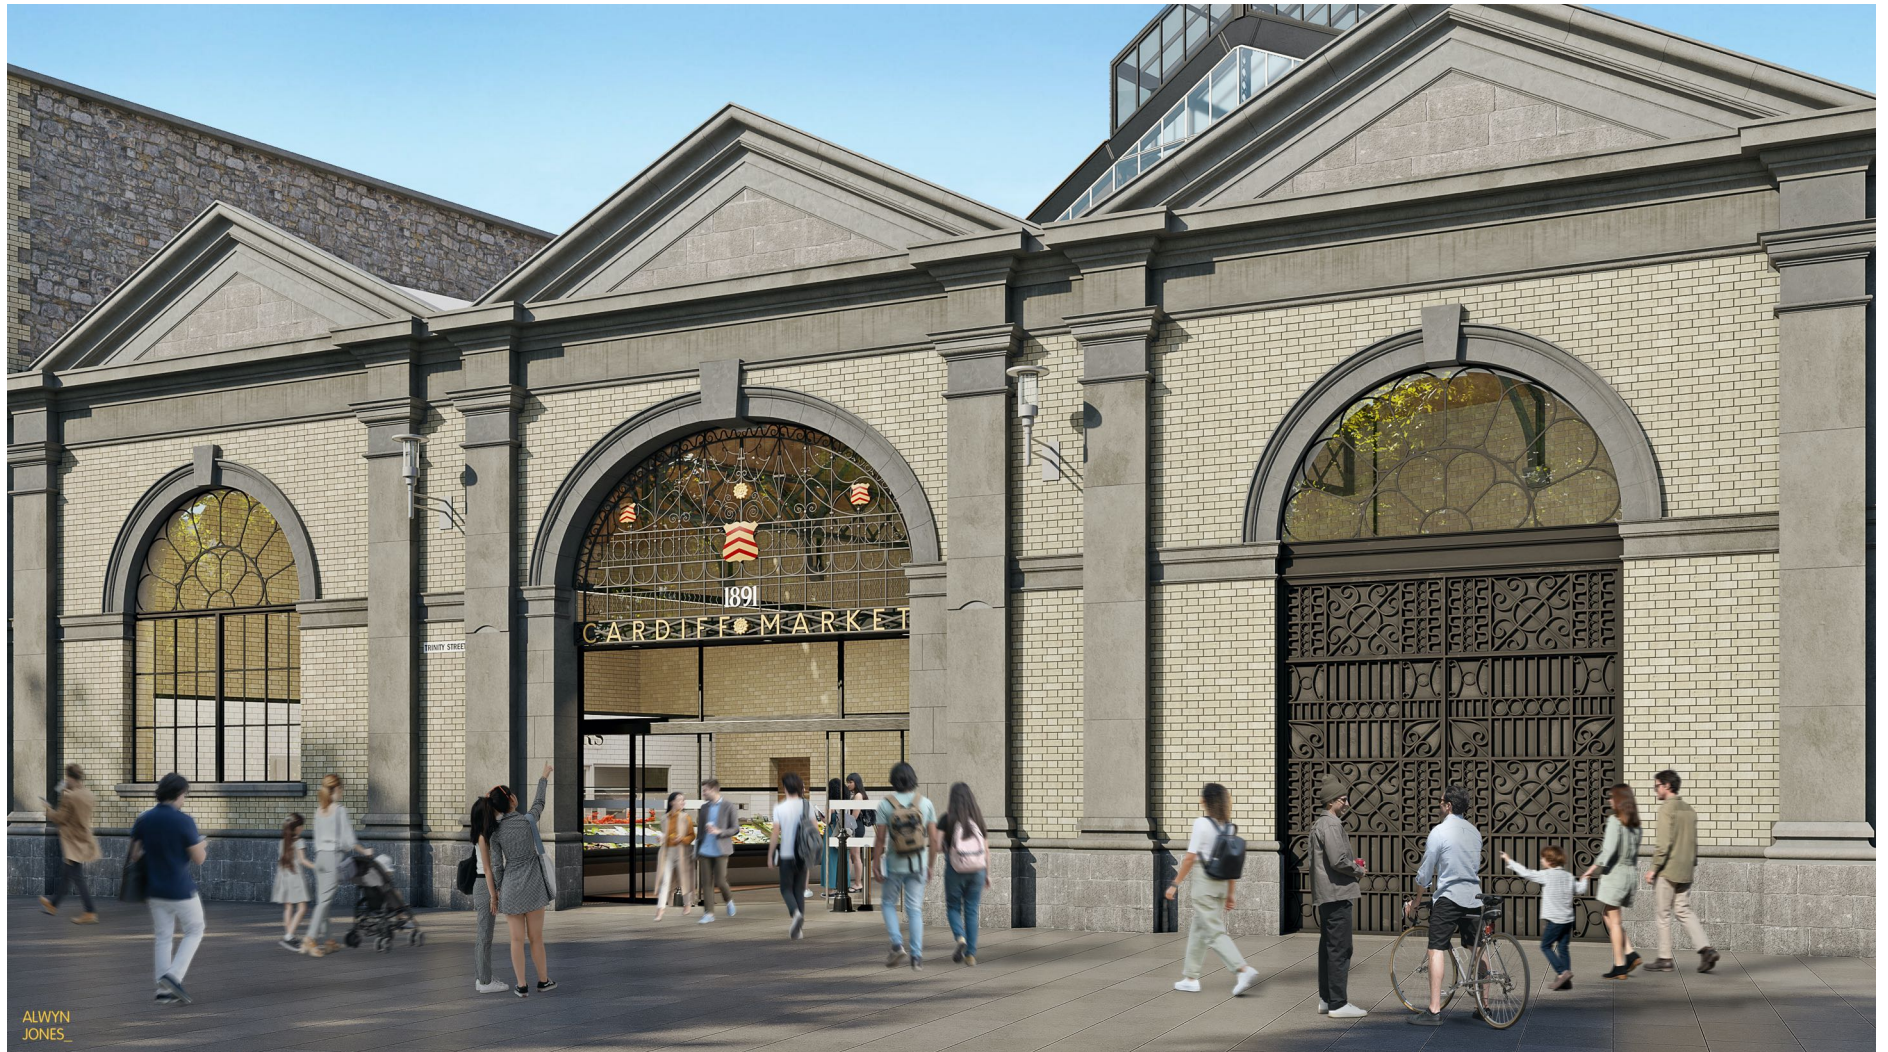
CGI View of Trinity Street elevation.

Modern Accretions removed, elevation cleaned and refurbished with new entrance doors and gates to side opening.

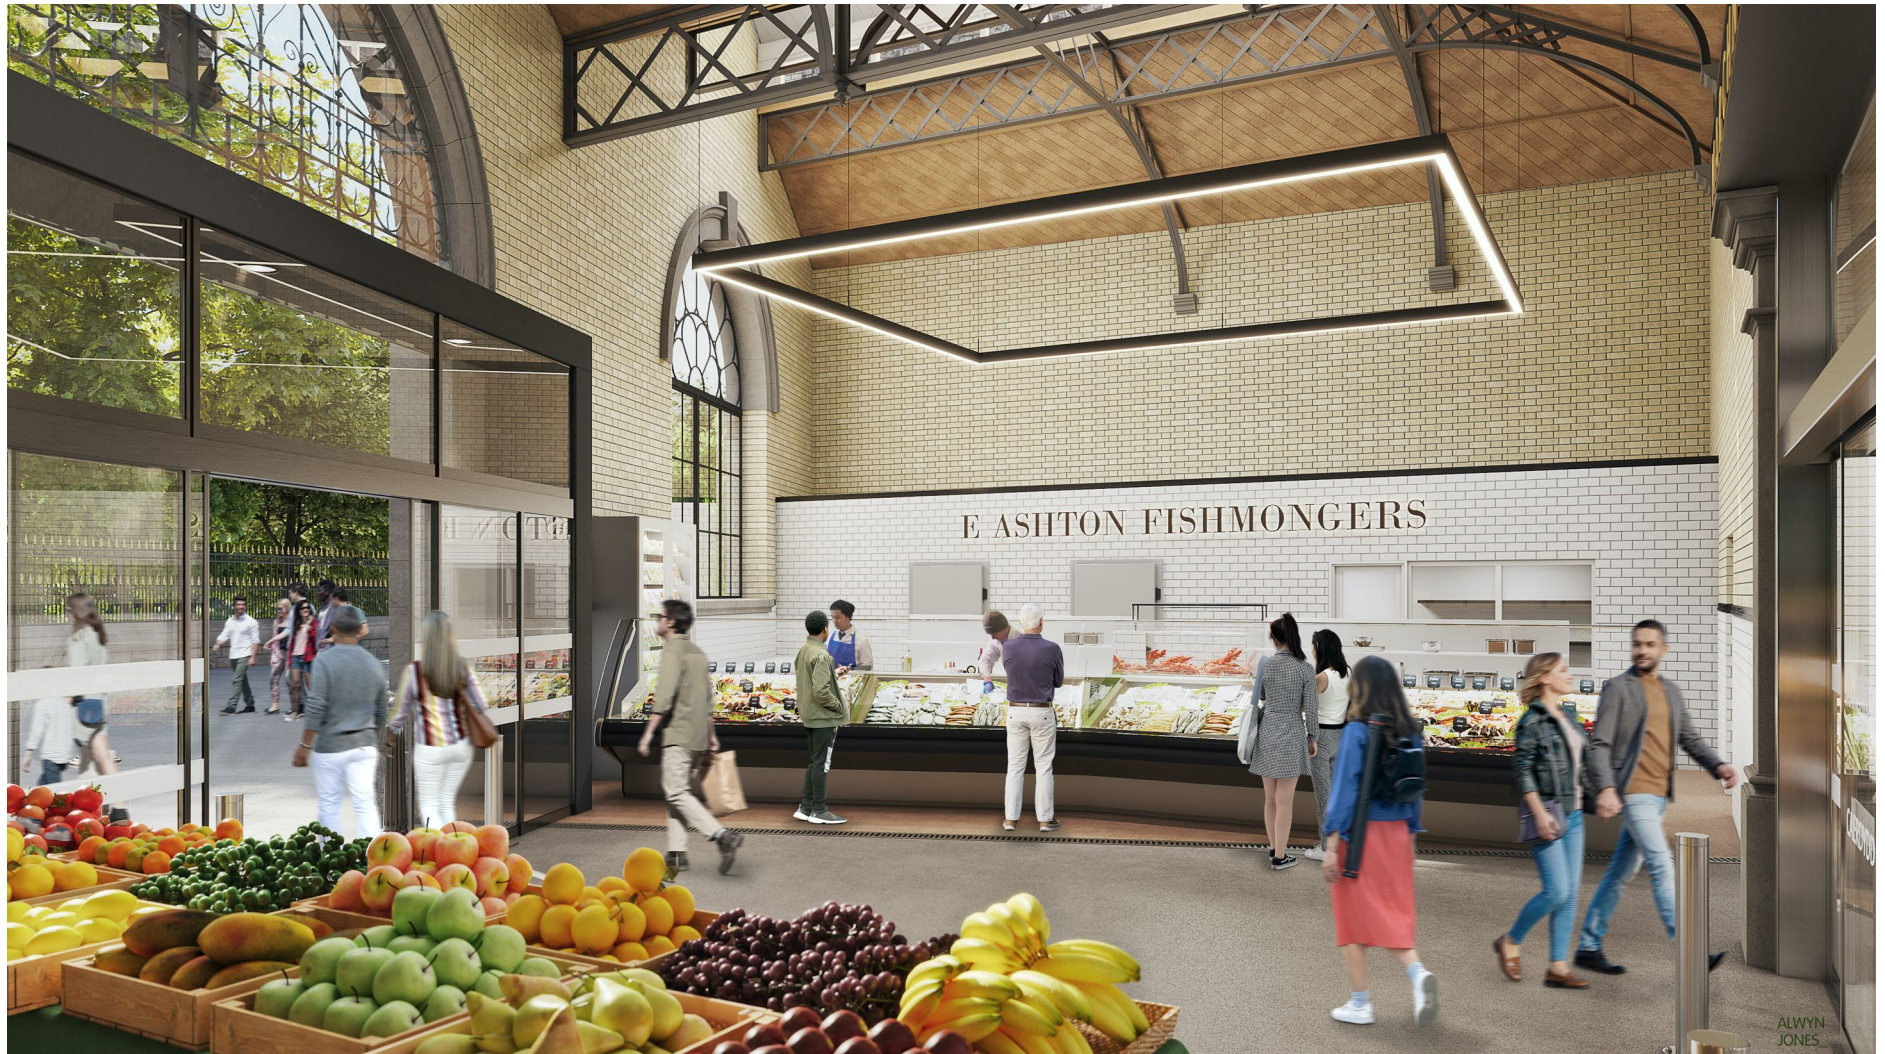
CGI of New arrangement to Fish Market.
Modern mezzanine floor removed, original form of market reintroduced and fish stall refurbished.

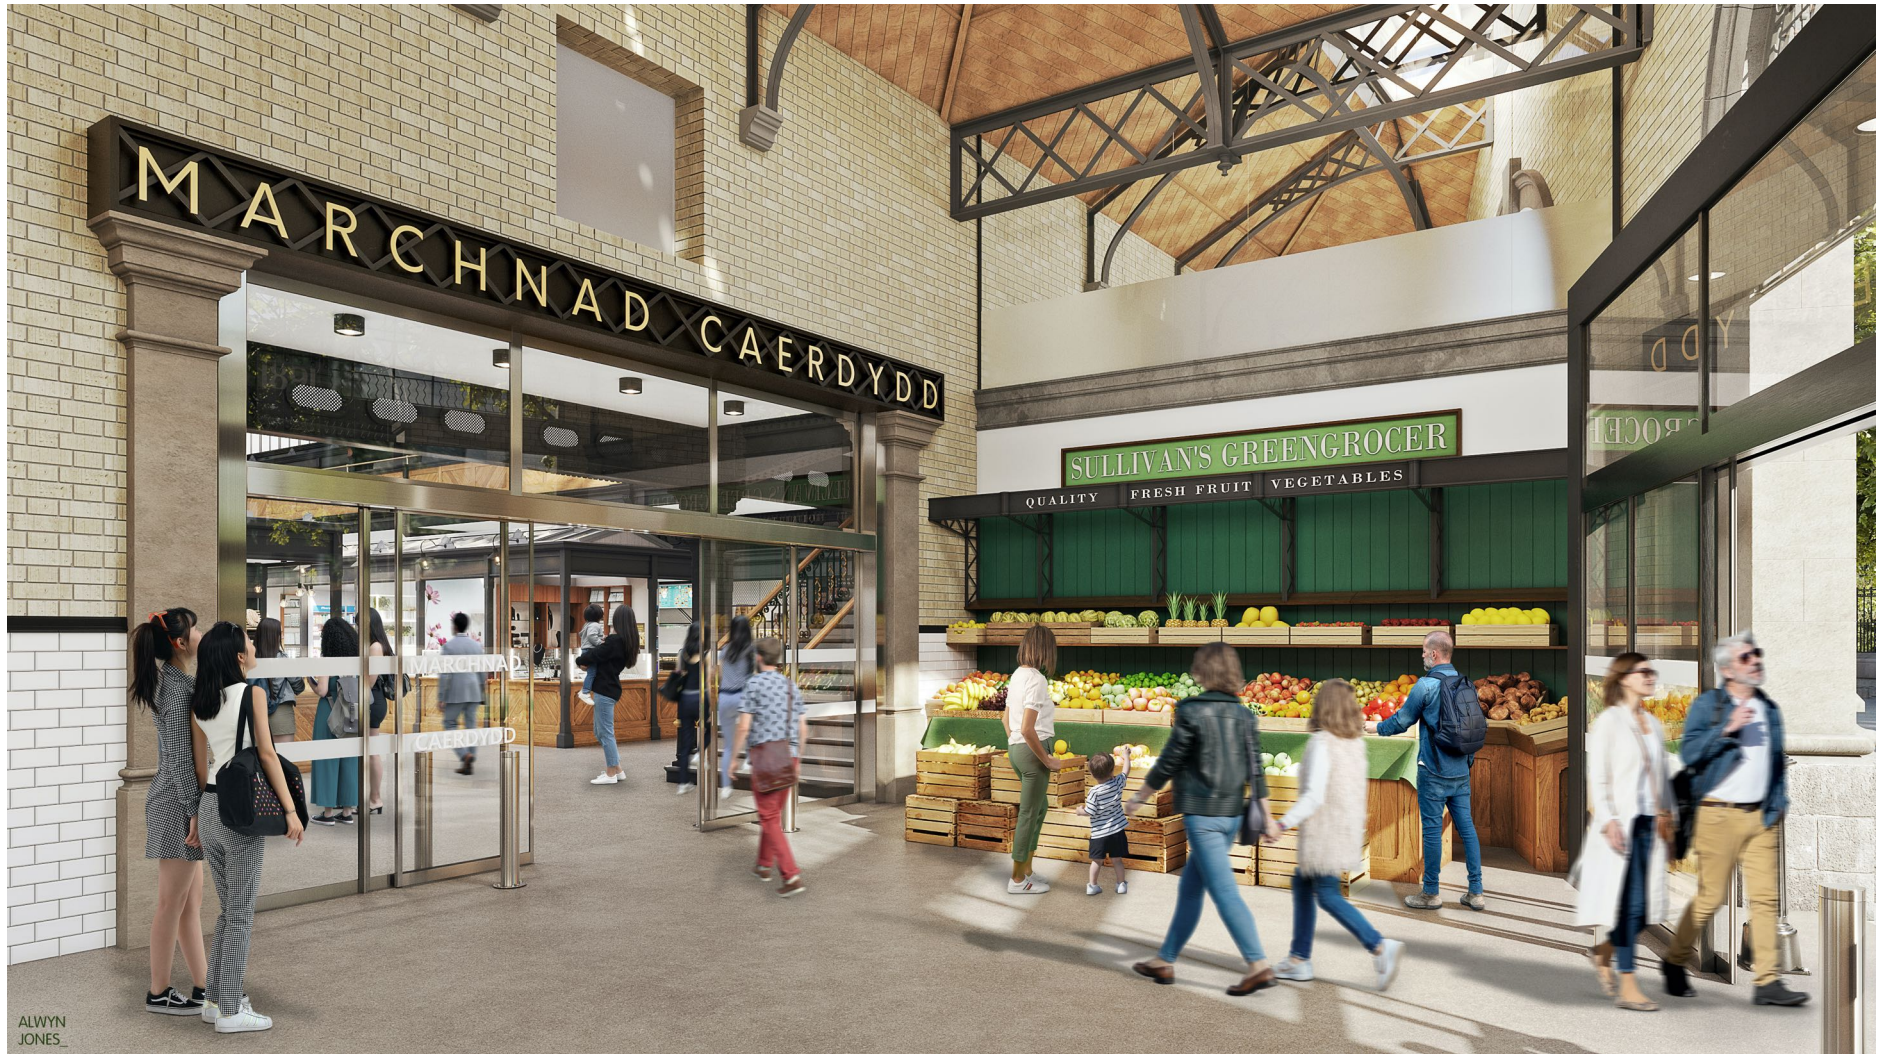
CGI of New arrangement to Fish Market.
New market hall entrance doors and first floor Education Suite above Bin Store.

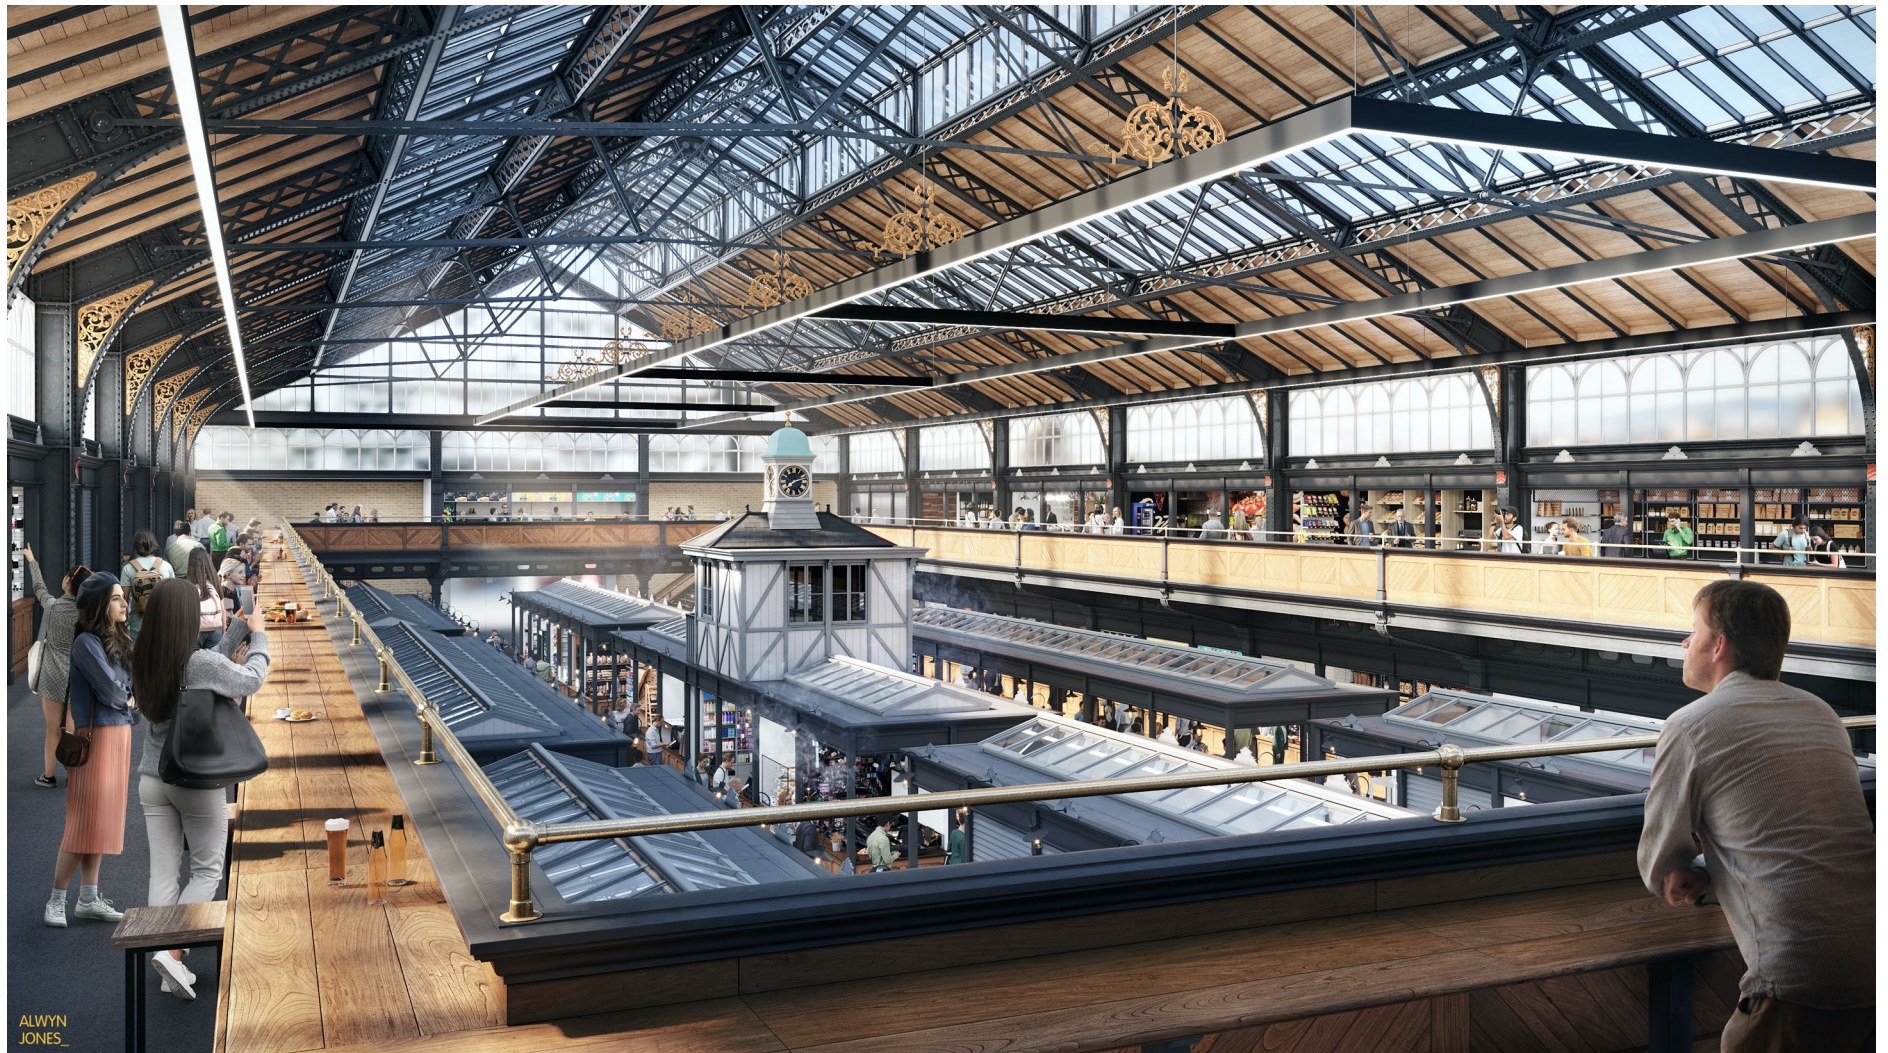
CGI View of Market Hall from gallery.
Modern paint finishes stripped off key components, refurbished interior and ground floor stalls.

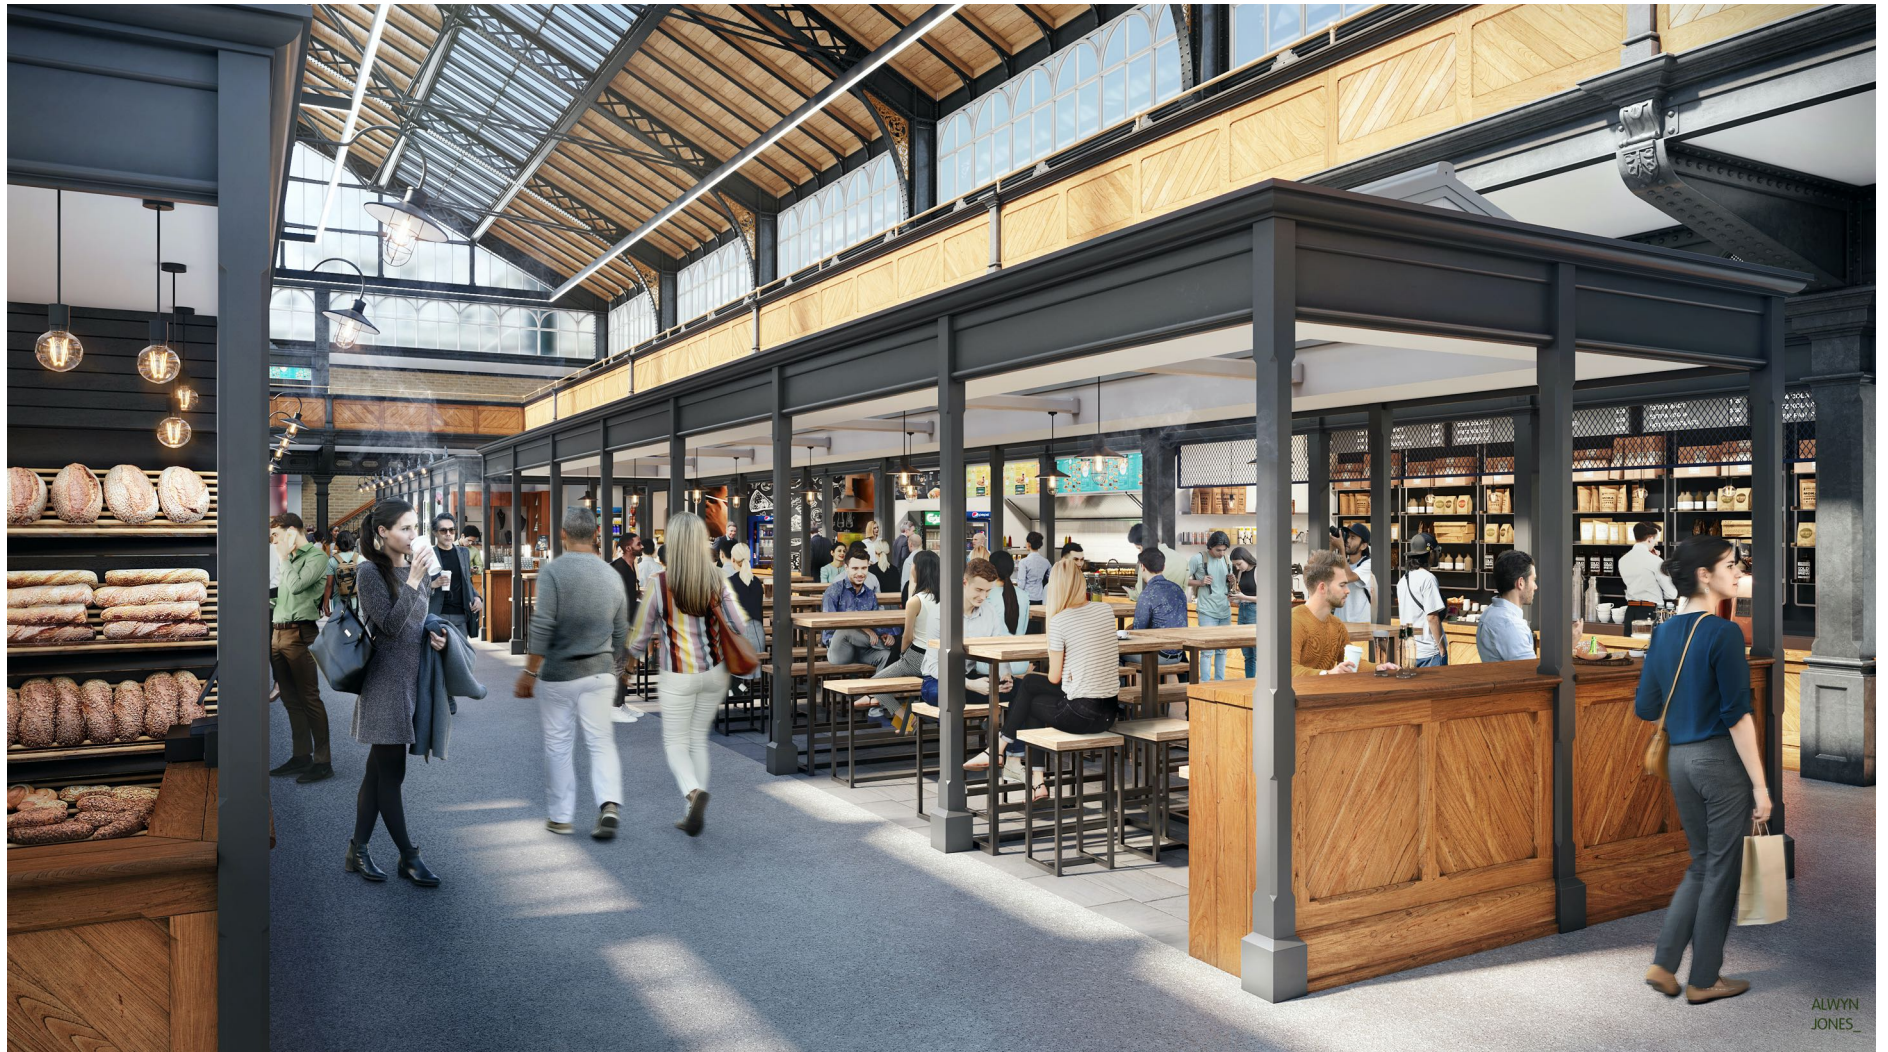
CGI of Ground Floor of Market Hall with new seating enclosure to centre section of north aisle. Enclosure design based on known details of original centre aisle stalls.
