Overview of RAAC Planks

RAAC at St. David's Hall

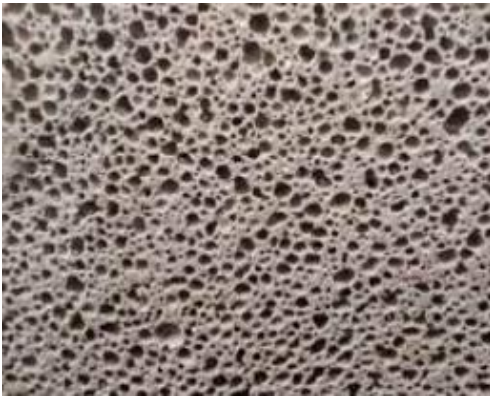
Re-inforced Autoclaved Aerated Concrete (RAAC) is a form of lightweight concrete that was used in roof, floor, cladding and wall construction in the UK from the mid-1950s to the early 1980s. It was a popular material at this time due to its low cost and a lightweight alternative to conventional reinforced concrete, making it a preferable choice as a roofing material. Often formed into pre-cast planks, RAAC has a bubbly appearance, creating a material of low density and weight, strengthened from within by steel wire or reinforced metal rods:

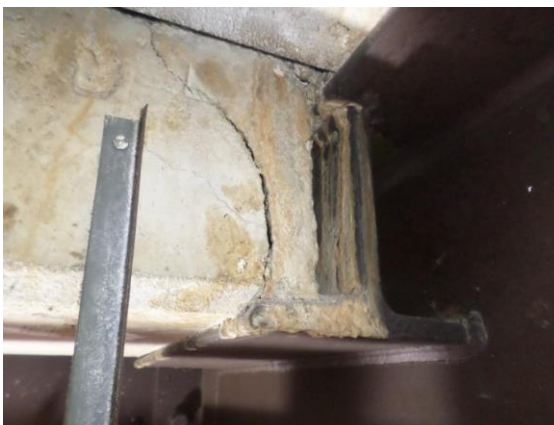
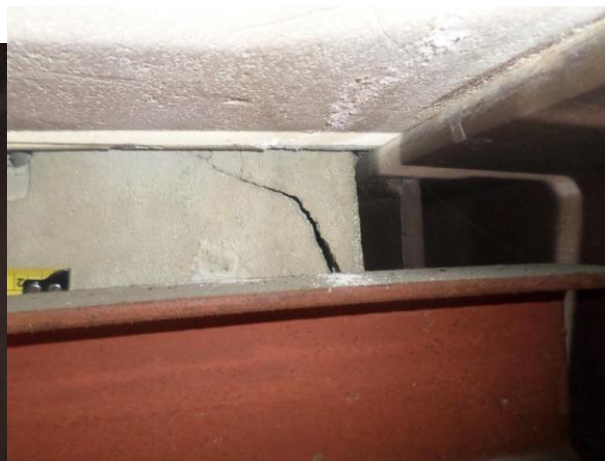
Visual inspections may identify cracking and deflections to exposed and visible areas of RAAC, however, an intrusive survey carried out by a professional structural engineer is recommended to be the only effective method of gaining a detailed insight into condition. The following images illustrate deterioration within RAAC planks that would not be identified from a visual inspection from the underside:

PLEASE NOTE - These are NOT images of RAAC at St. David's Hall

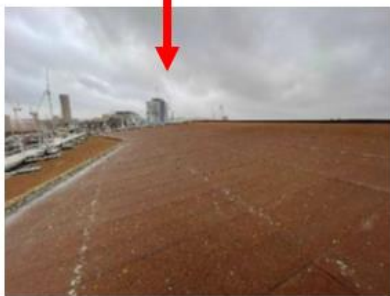
Sloped bitumen covered membrane over the RAAC plank roof

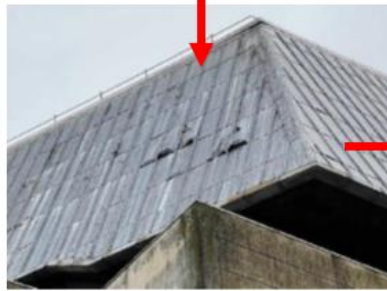
Vertical lead clad mansard surrounding the roof area, visible from street level

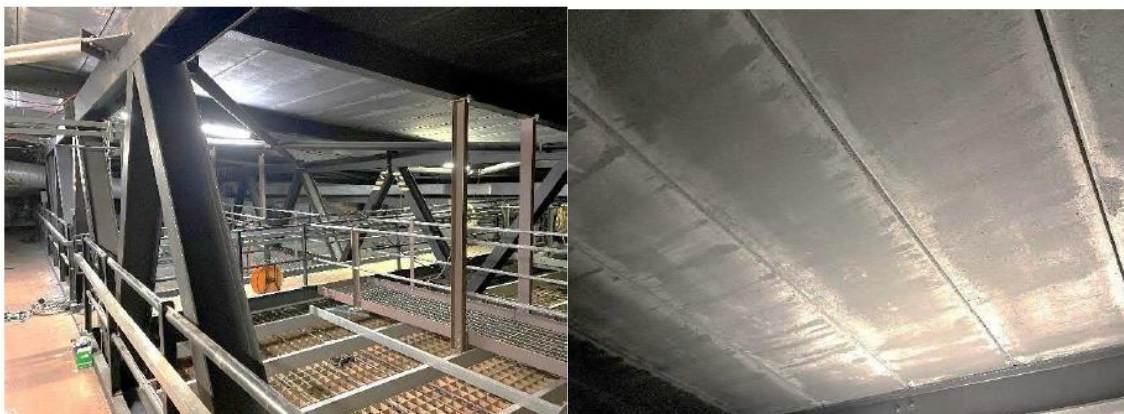
The below images show the space between the ceiling and roof at St. David's Hall and a closer view of a section of RAAC planks taken from below looking upwards:
