## ST DAVID'S HALL - RAAC ROOF PLANK SURVEY

TYPE OF DOCUMENT (VERSION) PUBLIC

PROJECT NO. 70086249

OUR REF. NO. WSP-XX-XX-RP-S-000001

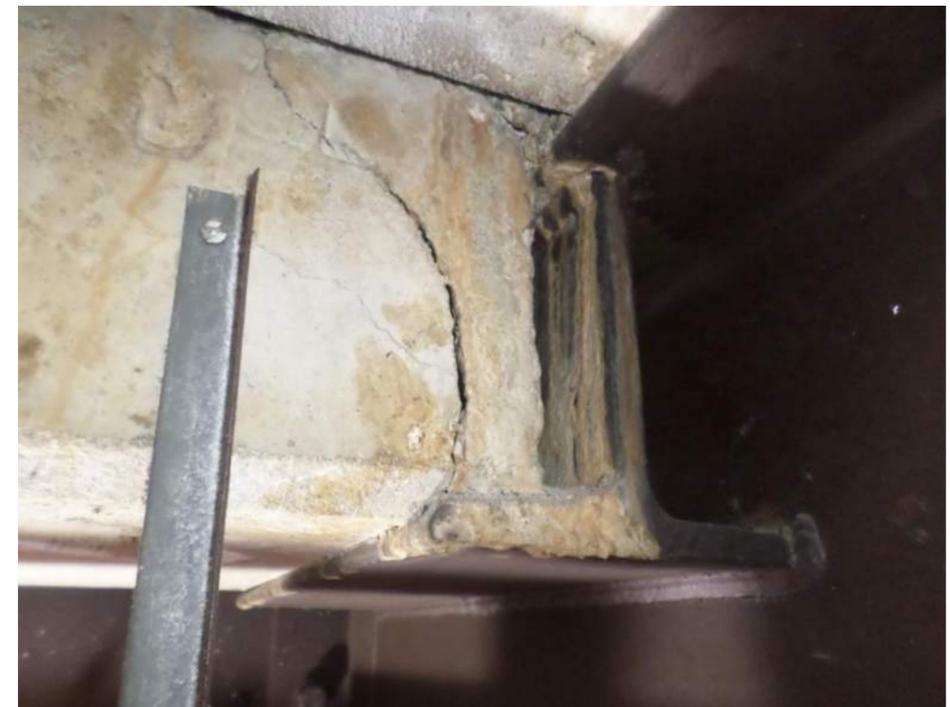
Shear failure of RAAC plank – **NOT ST DAVIDS HALL**

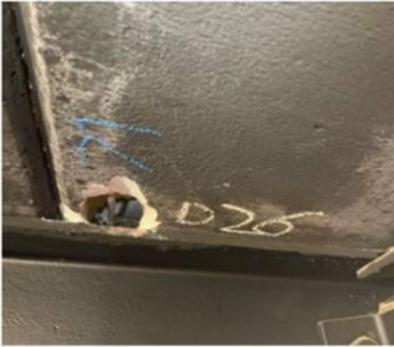
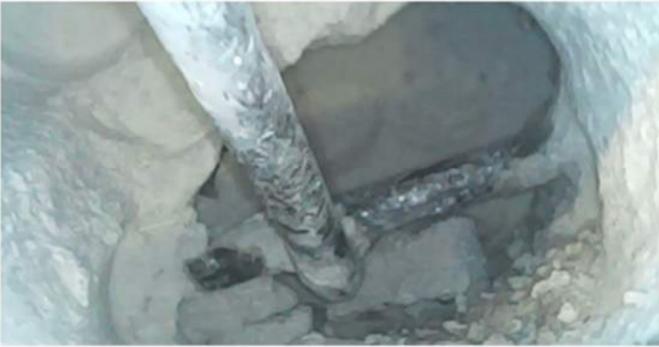
Location	Bearing on UB, RHS (mm)	Bearing on UB, LHS (mm)	Extent of transverse bar in bearing zone (mm)	Images
D26	71	60	60

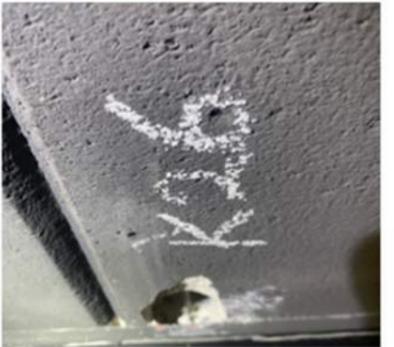
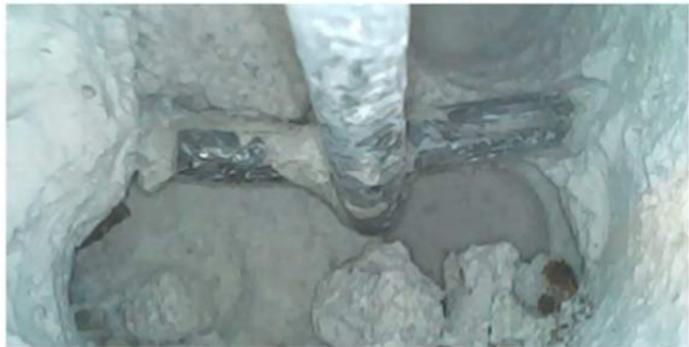
K26	Measurement not obtained due to obstruction by debris or infill between adjacent planks.	72	52

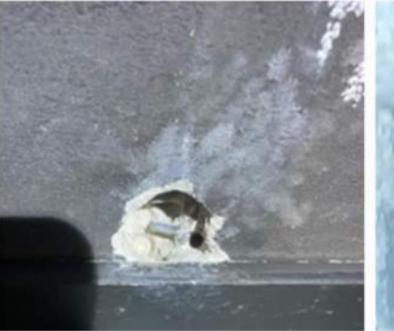
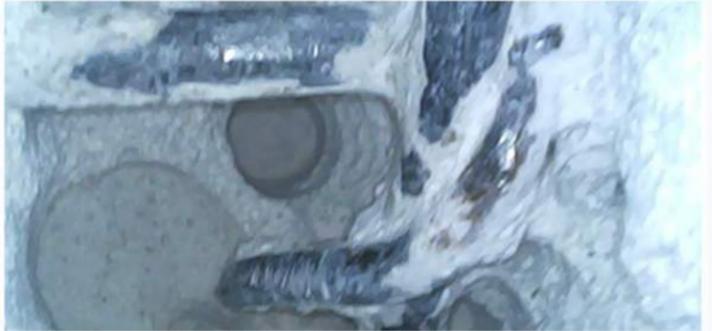
H60	73	Measurement not obtained due to obstruction by debris or infill between adjacent planks.	68

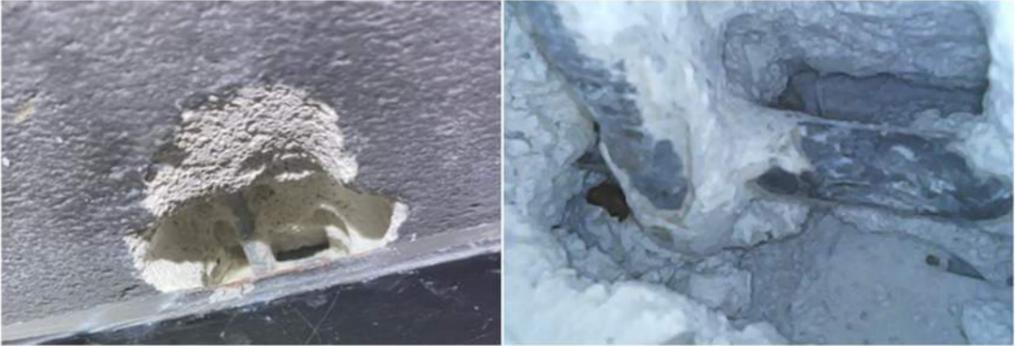
D71	84	64	51

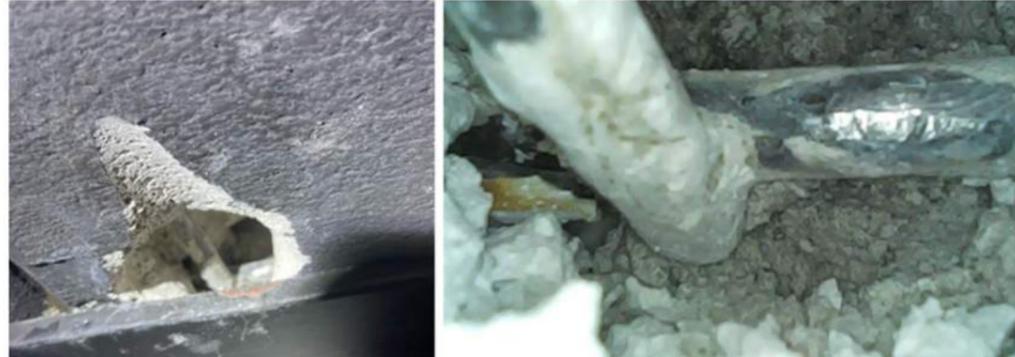
D68	71	66	55

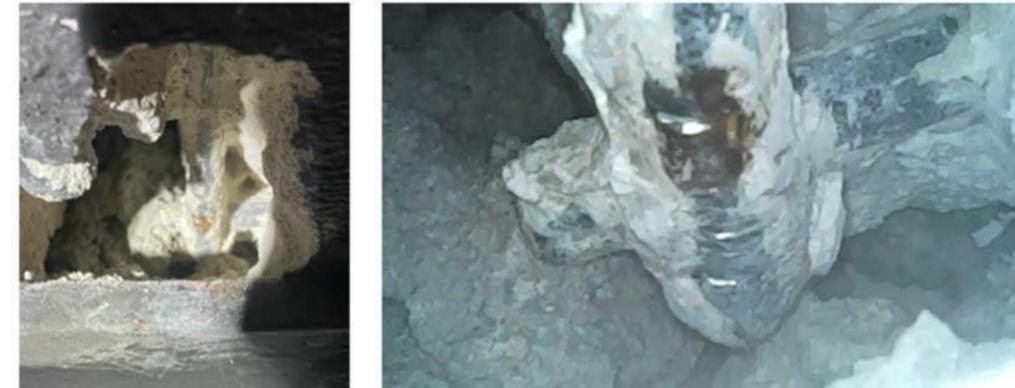
G79	62	81	47
